TRANSFORMING URBAN ROADS IN INDIA

THE
TENDER S.U.R.E.
IMPACT
BENGALURU

**TENDER
S.U.R.E.** | Specifications for **U**rban **R**oads **E**xecution

April 2025

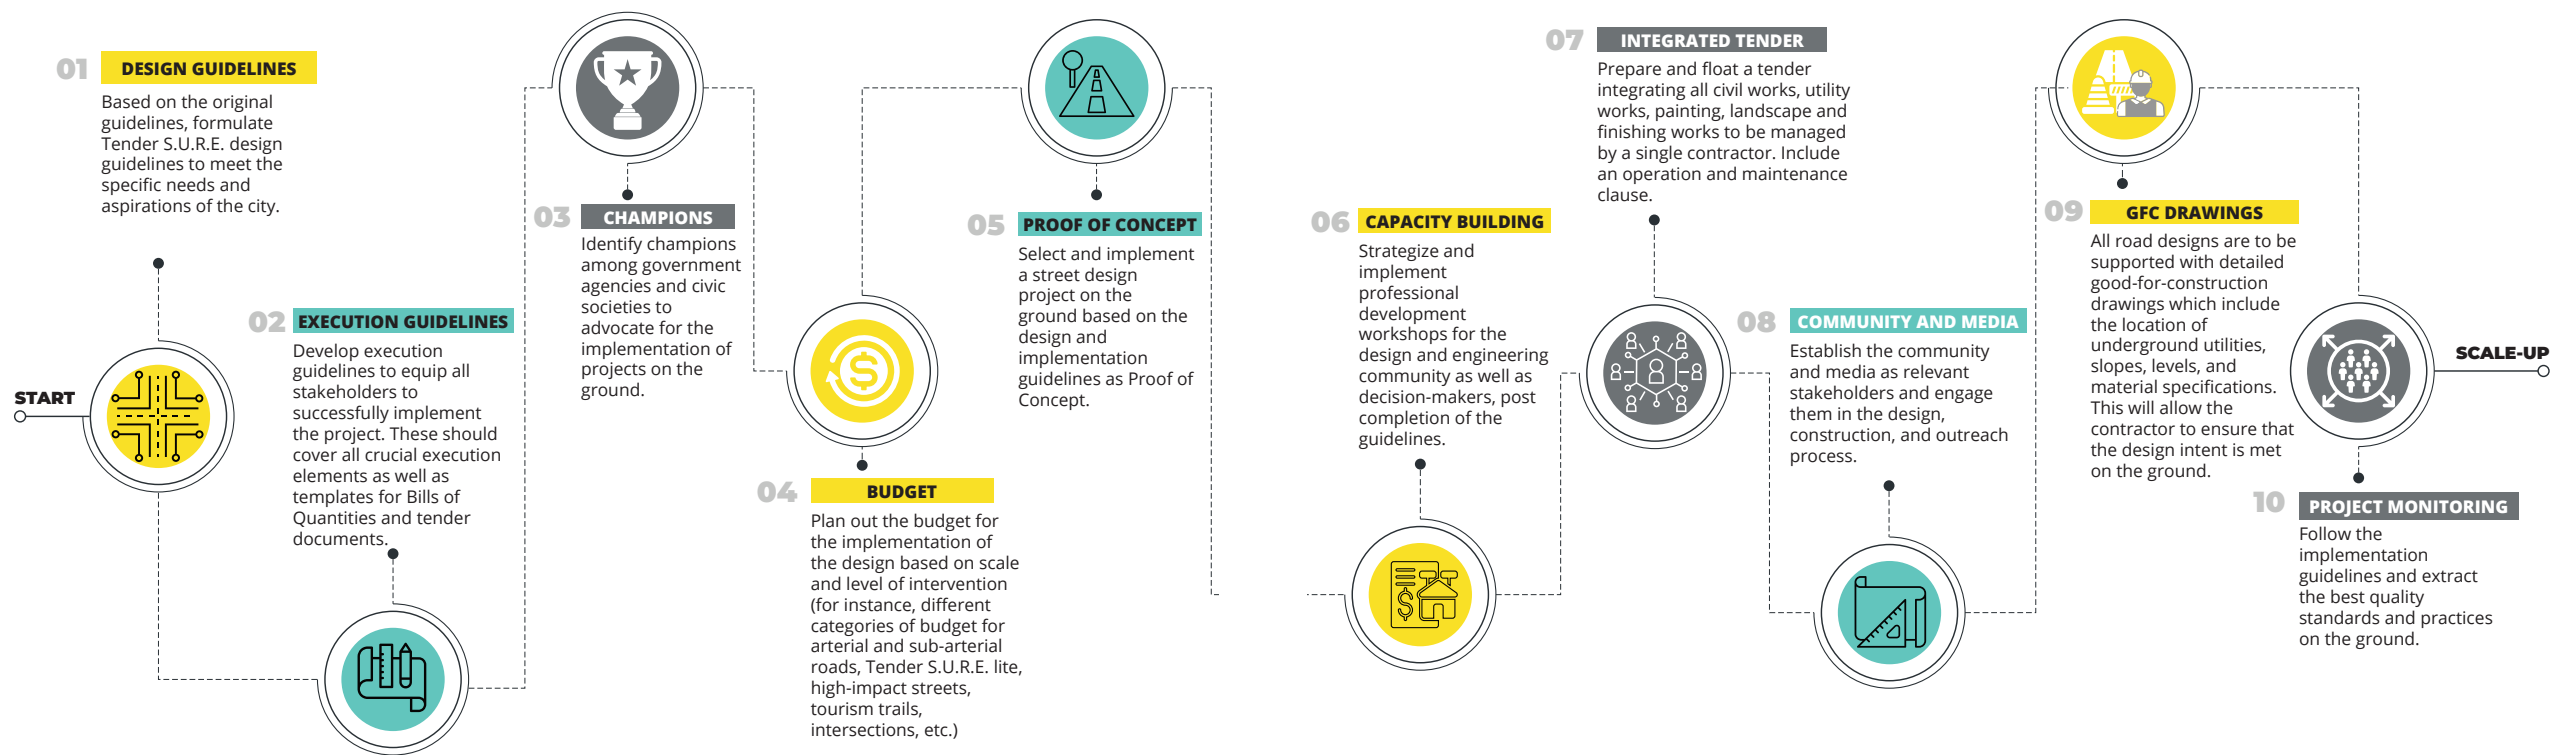
Figure 02. Steps to build a Tender S.U.R.E. road

The construction of a guidelines-compliant Tender S.U.R.E. road follows a 10-step process, from conception to implementation. It is designed to meet the objectives stated in *Section 1.2* | on page 20, and is delineated in *Figure 02* below.

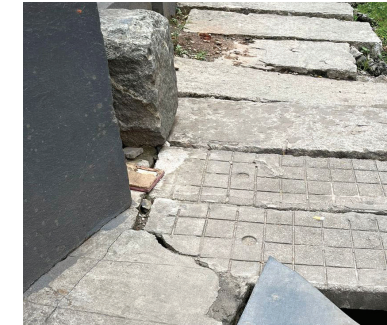
DEVANGA SAMAJA ROAD

Uneven and broken footpath slabs

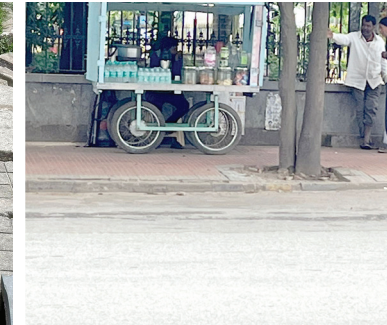
Vendors encroaching on footpaths

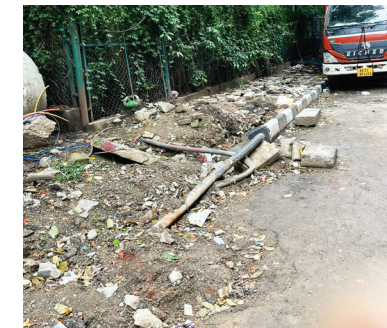
ULSOOR BAZAAR STREET

Broken footpath; rubble dumped on footpath

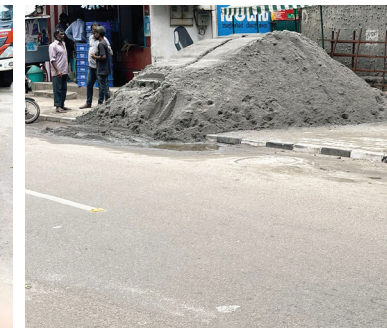
Construction material dumped on footpath

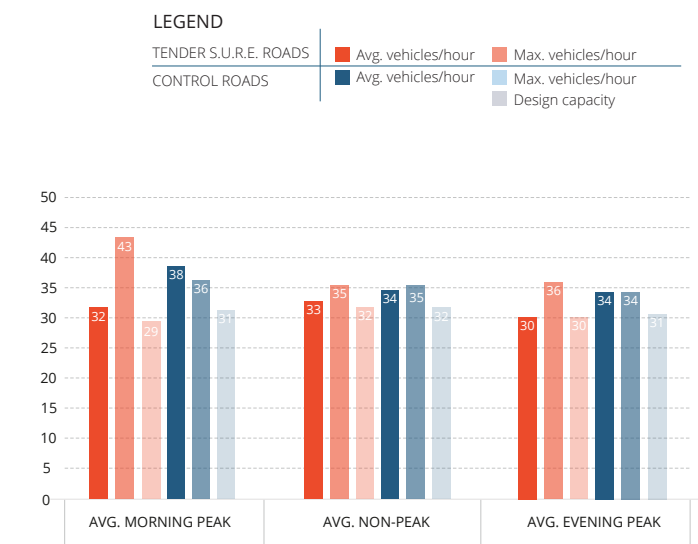
Figure 15. Traffic speed on selected sub-arterial, collector, and local roads

In combination with traffic volume, speed of movement can act as a good indicator of obstructions or congestion. The study reveals that while vehicular speed across all 13 roads falls significantly below the recommendations, Tender S.U.R.E. roads, on average, show marginally higher speeds than control roads (refer Section 5.8 | on page 102).

A relatively more consistent speed is observed throughout the day on Tender S.U.R.E. roads, without much variation in peak and non-peak hour speeds. This is evidence of both, consistency of flow and an absence of serious congestion.

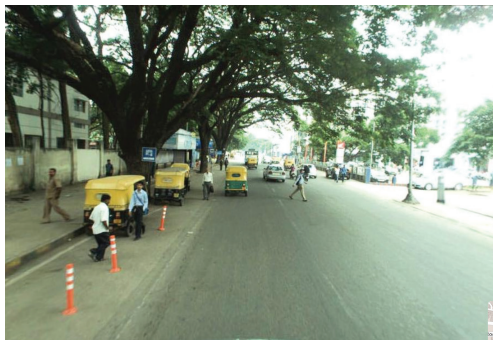
Impact of Tender S.U.R.E.
Residency Road

Before Tender S.U.R.E.

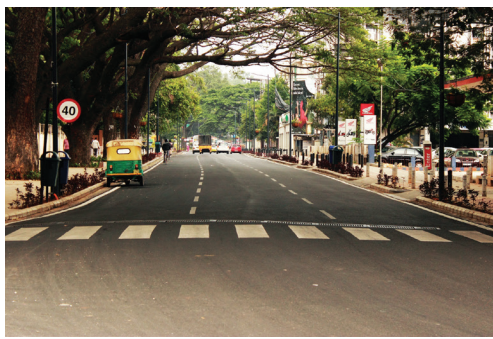
After Tender S.U.R.E.

Introduction of pedestrian crossing, uninterrupted footpath, and street elements to enhance the functioning of Residency Road.

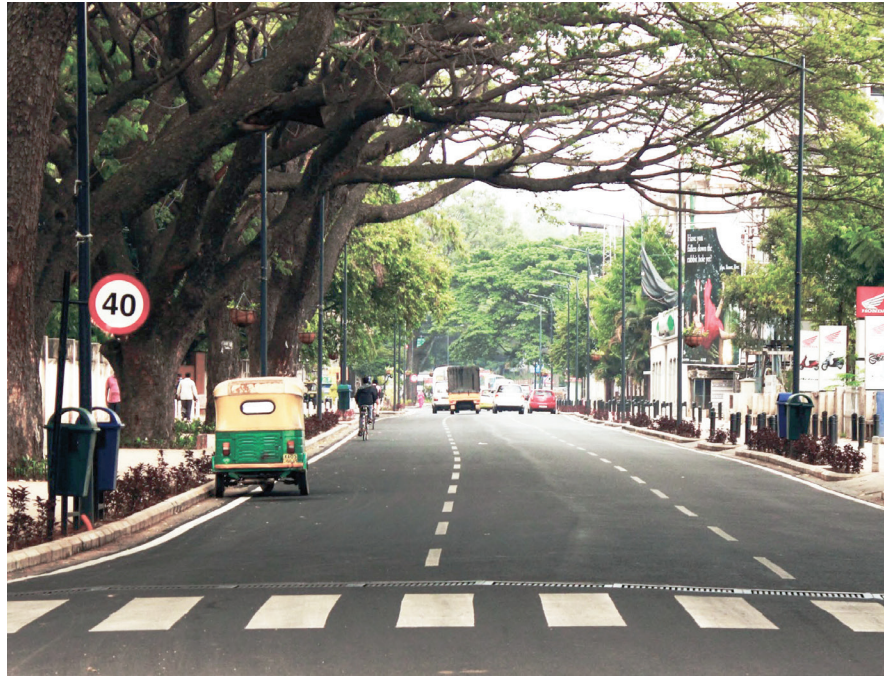
Figure A_02. St Mark's Road

BUS STOPS 3 bus stops; inconveniently placed, inaccessible, and passengers waiting in the lane	1 designated bus shelter at a suitable distance from intersections, with seating, lighting, space for maps, etc.	1 designated bus shelter in good condition, at a suitable distance from intersections, with seating, lighting, space for maps, etc.	100%
	LIGHTING 66 poorly-placed sodium-vapour lamps resulting in non-uniform lighting	58 LED lamps placed at regular intervals to provide uniform lighting	58 LED lamps placed at irregular intervals at some points	100%
ELEMENTS	LANDSCAPE Not available on any side	750mm wide and 310 m long landscape strip as buffer between travel lanes and pedestrian footpath	310m long landscape strip; some trees on footpath causing obstruction	100%
	WASTE MANAGEMENT Not available on any side	40 new bins for segregated waste collection at 30m intervals	40 new bins for segregated waste collection at 30m intervals	100%

UGD	UNDERGROUND UTILITIES Utilities existed at 3m depth under travel lanes causing leaks and frequent road digging	1,872m of ducts for power, telecom and gas with 28 access chambers; 1,658m of new sewer lines with 56 access chambers	All networked infrastructure moved underground with frequent access chambers; no cables seen above	100%
	STORMWATER DRAINAGE Utilities existed at 3m depth under travel lanes causing leaks and frequent road digging	1,158m of underground stormwater pipes with 58 percolation-cum-catch pits	Underground stormwater drains with kerb-side gratings and landscape pits with soil for rainwater percolation	100%
ADDED INFRA	CYCLE TRACK Not available on any side	1.5m–2m wide cycle track on each side; 810m of designated, continuous cycle track	1.7m wide cycle track on each side; track is discontinuous in some parts	83.3%
	VENDOR KIOSKS Not available on any side	Areas in the footpath dedicated to vendors/hawkers which do not cause an obstruction to the pedestrians	Provision of areas in the footpath dedicated to vendors/hawkers which do not obstruct pedestrian movement	100%

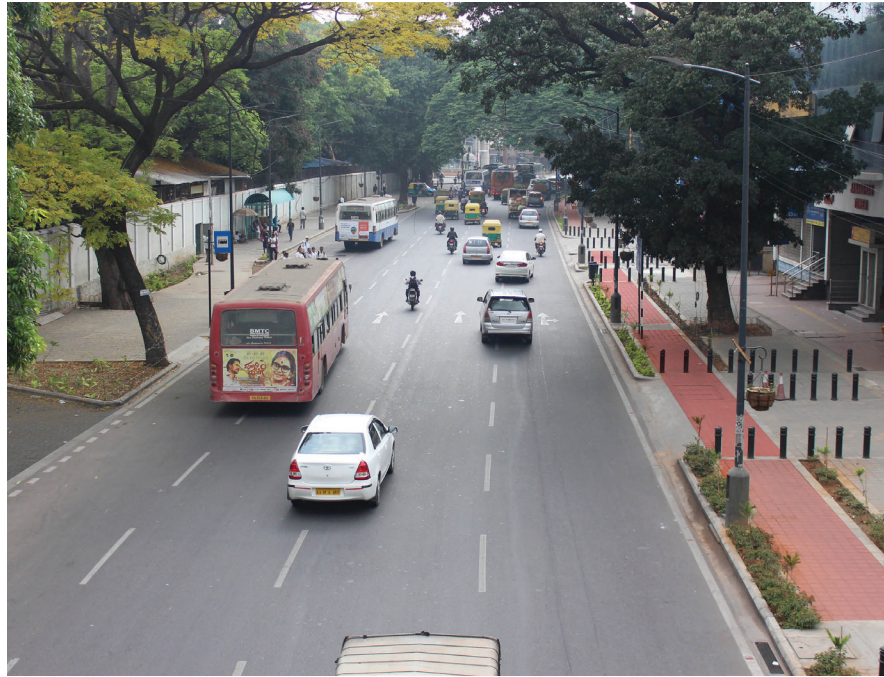
Figure A_04. Residency Road

STORMWATER DRAINAGE Utilities existed at 3m depth under travel lanes causing leaks and frequent road digging	1,838m of underground stormwater pipes with 70 percolation-cum-catch pits	Underground stormwater drains and landscape pits with soil for rainwater percolation; kerb side drains are missing gratings	66.7%
	CYCLE TRACK Not available on any side	1.5m width cycle track on each side; 866m of designated, continuous cycle track	1.3m wide cycle track on each side	50%
ADDED INFRA	VENDOR KIOSKS Not available on any side	Areas in the footpath dedicated to vendors/hawkers which do not cause an obstruction to pedestrians	Provision of areas in the footpath dedicated to vendors/hawkers which do not obstruct pedestrian movement	100%
	PARKING BAYS Designated parking bays for 2-, 3-, and 4-wheelers as well as bicycles	Designated parking bays for 2-, 3-, and 4-wheelers as well as bicycles to avoid haphazard parking on roads	Designated parking for– 2-wheelers: 3 3-wheelers: 3 4-wheelers: 1 Bicycles: 2	100%

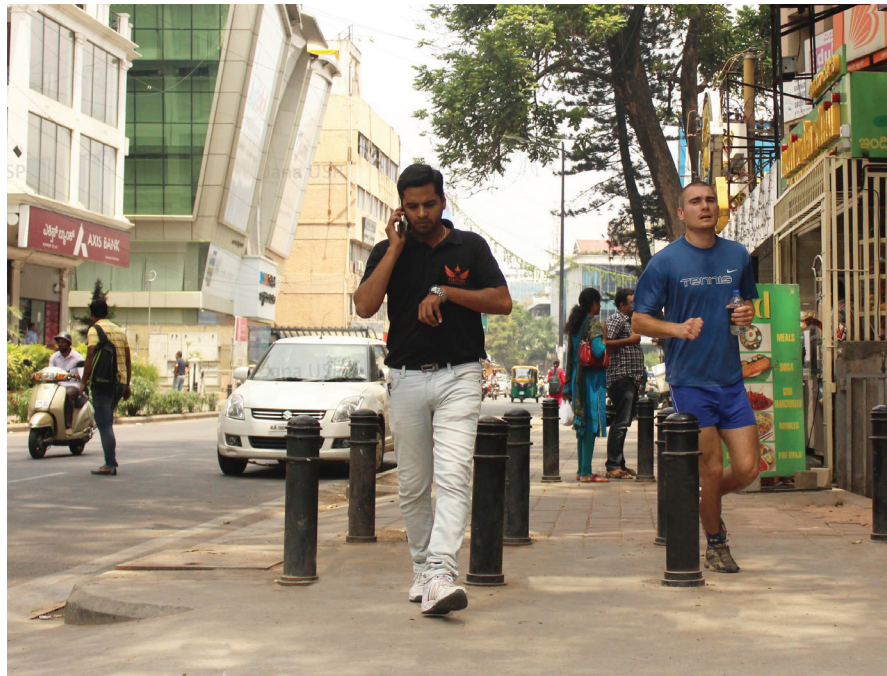
Figure A_06. Cunningham Road

PRE TENDER S.U.R.E.	INTENDED DESIGN	POST TENDER S.U.R.E.	SCORE
FOOTPATH	FOOTPATH WIDTH 2m–5.9m irregular width. Absence of tactile pavers, ramps, buffers like bollards, and pedestrian crossings	Min. 2m footpath on both sides; 1,500m of uninterrupted footpath with tactile pavers, ramps at kerb edges, bollards with 1m gaps, and accessible pedestrian crossings	2.4m–4.6m wide footpath on both sides. Discontinuous tactile pavers, ramps at kerb edges of 150mm height, bollards at 1m gap and damaged pedestrian crossings at some points	88.9%
	QUALITY OF MATERIAL & CONSTRUCTION Irregular footpath surface with several encroachments and obstacles	Concrete pavers for footpaths, laid on a sand bed without any cement; 5-layer composition for travel lanes	Unable to monitor this feature post execution	N/A
TRAFFIC MGMT	ROAD WIDTH 19m–24m ROW; 6m–9m total travel lane width; 3 lanes; no designated parking	6m total travel lane width; 2 lanes; with shoulder for halting and designated parking bays	6m total travel lane width; 3 lanes; with shoulder for halting and designated parking bays	100%

BUS STOPS Not available	2 designated bus shelters at a suitable distance from intersections, with seating, lighting, space for maps, etc.	1 designated bus shelter in good condition, at a suitable distance from intersections, with seating, lighting, space for maps, etc.	50%
	LIGHTING 76 poorly-placed sodium-vapour lamps resulting in non-uniform lighting	74 LED lamps placed at regular intervals to provide uniform lighting	74 sodium-vapour lamps placed at irregular intervals at some points	33.3%
ELEMENTS	LANDSCAPE Not available on any side	105sqm increase in landscape area including a continuous 0.4m wide landscape strip along the footpath	105sqm increase in landscape area; continuous landscape strip along the footpath	100%
	WASTE MANAGEMENT Not available on any side	42 new bins for segregated waste collection at 30m intervals	No bins installed	0%
UGD	UNDERGROUND UTILITIES Utilities existed at 3m depth under travel lanes causing leaks and frequent road digging	4,079m power and telecom ducts with 19 access chambers; 1,872m ducts for gas; 1,500m sewer lines with 77 access chambers	Some poles for broadband cable are seen above the ground; electricity cables not concealed	75%

STORMWATER DRAINAGE Utilities existed at 3m depth under travel lanes causing leaks and frequent road digging	1,377m of underground stormwater pipes with 60 percolation-cum-catch pits	Underground stormwater drains with kerb-side gratings and landscape pits with soil for rainwater percolation	100%
ADDED INFRA	CYCLE TRACK Not available on any side	1.5m width cycle track on each side; 706m of designated, continuous cycle track	Not implemented	0%
	VENDOR KIOSKS Not available on any side	Not intended in design		N/A
	PARKING BAYS Designated parking bays for 2-, 3-, and 4-wheelers as well as bicycles	Designated parking bays for 2-, 3-, and 4-wheelers as well as bicycles to avoid haphazard parking on roads	Designated parking for— 2-wheelers: 4 3-wheelers: 5 4-wheelers: 2 Bicycles: 2	100%

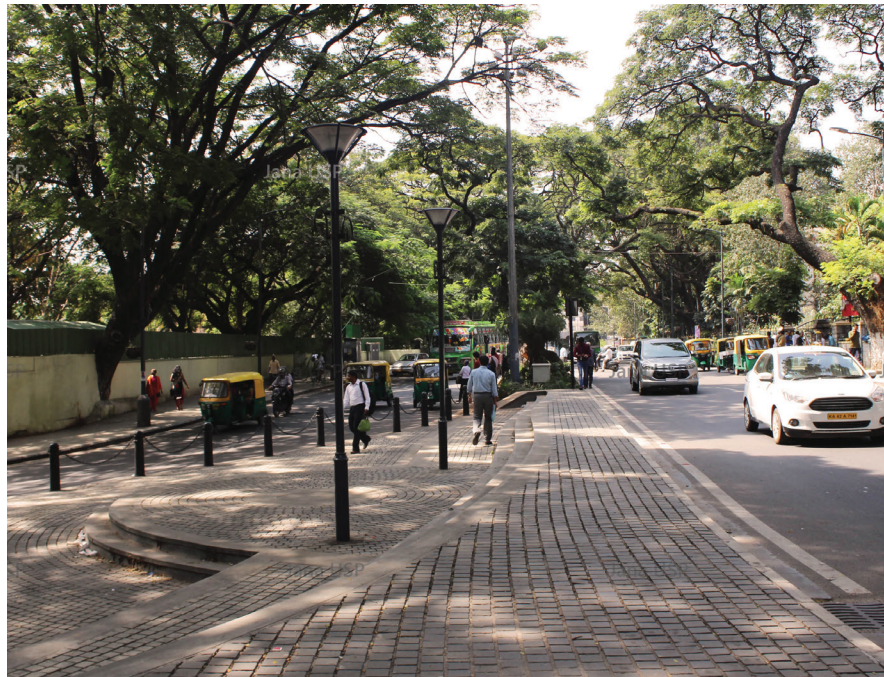
Figure A_08. Commissariat Road

BUS STOPS Not available	1 designated bus shelter at a suitable distance from intersections, with seating, lighting, space for maps, etc.	1 designated bus shelter in good condition, at a suitable distance from intersections, with seating, lighting, space for maps, etc.	100%
	LIGHTING 30 poorly-placed sodium-vapour lamps resulting in non-uniform lighting.	30 LED lamps placed at regular intervals to provide uniform lighting.	30 LED lamps placed at regular intervals to provide uniform lighting.	100%
ELEMENTS	LANDSCAPE Not available on any side	556sqm increase in landscape area including a continuous 0.4m wide landscape strip along the footpath	556sqm increase in landscape area including a continuous 0.4m wide landscape strip; some trees on footpath causing obstruction	83.3%
	WASTE MANAGEMENT Not available on any side	16 new bins for segregated waste collection at 30m intervals	16 new bins for segregated waste collection at 30m intervals	100%

UGD	UNDERGROUND UTILITIES Utilities existed at 3m depth under travel lanes causing leaks and frequent road digging	1,433m power ducts with 19 access chambers; 2,936m telecom ducts with 12 access chambers; 885m sewer lines with 31 access chambers	Some poles for broadband cable are seen above the ground; electricity cables not concealed	75%
	STORMWATER DRAINAGE Utilities existed at 3m depth under travel lanes causing leaks and frequent road digging	575m of underground stormwater pipes with 15 percolation-cum-catch pits	Underground stormwater drains with kerb-side gratings and landscape pits with soil for rainwater percolation	100%
	CYCLE TRACK Not available on any side	Not intended in design	Not implemented	N/A
ADDED INFRA	VENDOR KIOSKS Not available on any side	Not intended in design	Not implemented	N/A
	PARKING BAYS Designated parking bays for 2-, 3-, and 4-wheelers as well as bicycles	Designated parking bays for 2-, 3-, and 4-wheelers as well as bicycles to avoid haphazard parking on roads	Designated parking for– 2-wheelers: 5 3-wheelers: 3 4-wheelers: 1 Bicycles: 2	100%

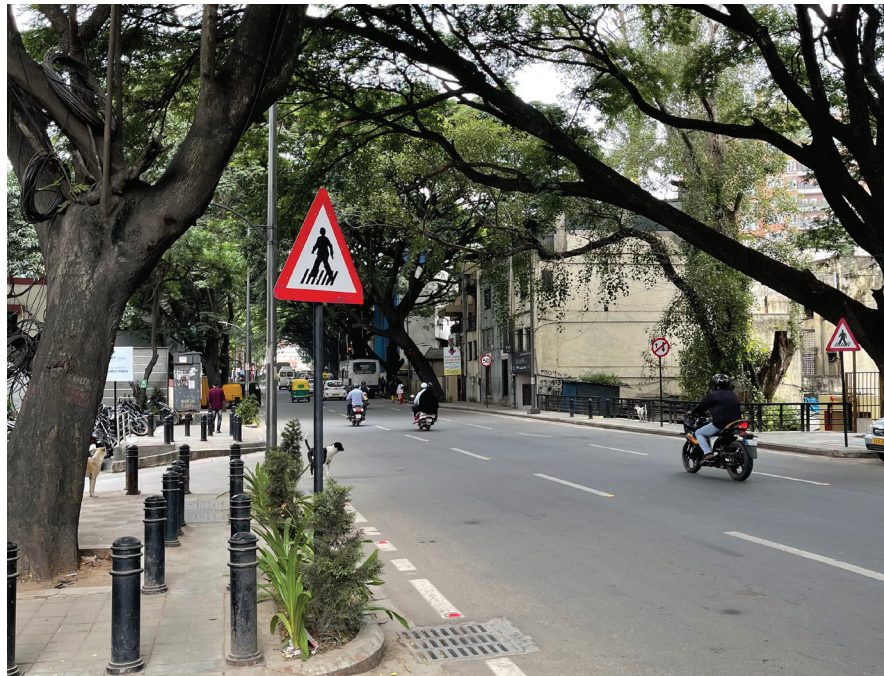
Figure A_10. Queens Road

BUS STOPS 2 bus stops	2 designated bus shelters at a suitable distance from intersections, with seating, lighting, space for maps, etc.	2 designated bus shelters in mediocre condition with inadequate seating and lighting, and no space for info.	43.7%
ELEMENTS	LIGHTING 79 poorly-placed sodium-vapour lamps resulting in non-uniform lighting.	78 LED lamps placed at regular intervals to provide uniform lighting.	78 sodium-vapour lamps placed at regular intervals to provide uniform lighting.	66.7%
	LANDSCAPE Not available on any side	654sqm increase in landscape area including a continuous 0.4m wide landscape strip along the footpath	654sqm increase in landscape area including a continuous 0.4m wide landscape strip along the footpath	100%
	WASTE MANAGEMENT Not available on any side	15 new bins for segregated waste collection at 30m intervals	No bins installed	0%
UGD	UNDERGROUND UTILITIES Haphazard underground power lines perpendicularly crossing the road at 3m below travel lane	11,373m of power ducts and 1,985m of new sewer lines with regular access chambers	All poles for broadband cable are seen above the ground; electricity cables are not all concealed	37.5%

STORMWATER DRAINAGE Haphazard underground utilities, 1 water line crossing the road below travel lane	1,438m of underground stormwater lines with percolation-cum-catch pits	Percolation-cum-catch pits provided around landscape, but side drains are inconsistent and gratings are missing	33.3%
ADDED INFRA	CYCLE TRACK Not available on any side	1.2m width cycle track on each side for all segments	Not implemented	0%
	VENDOR KIOSKS Not available on any side	Not intended in design		N/A
	PARKING BAYS Designated parking bays for 2-, 3-, and 4-wheelers as well as bicycles	Designated parking bays for 2-, 3-, and 4-wheelers as well as bicycles to avoid haphazard parking on roads	Designated parking for- 2-wheelers: 7 3-wheelers: 4 4-wheelers: 0 Bicycles: 0	100%
